GENESIS FORENSICS, INC.

OCTOBER 28, 2022

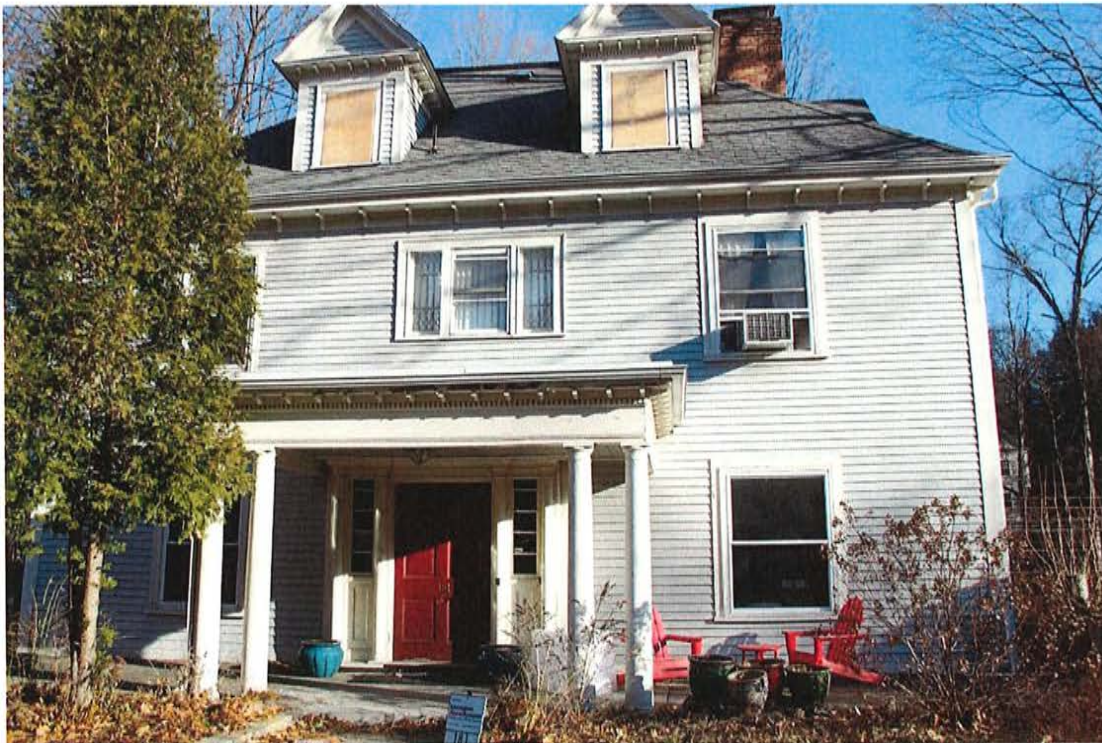
Photo: 1) 181 Clark Road, Brookline, MA

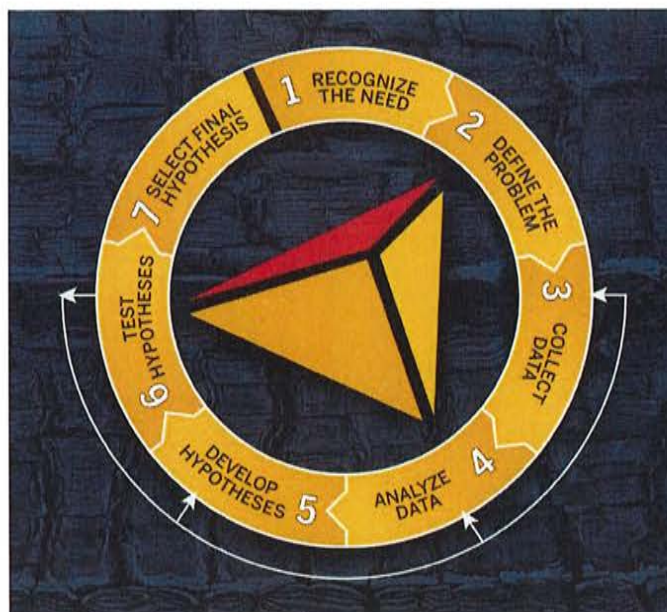
Figure 1) Scientific Method - NFPA 921 - 2021 edition

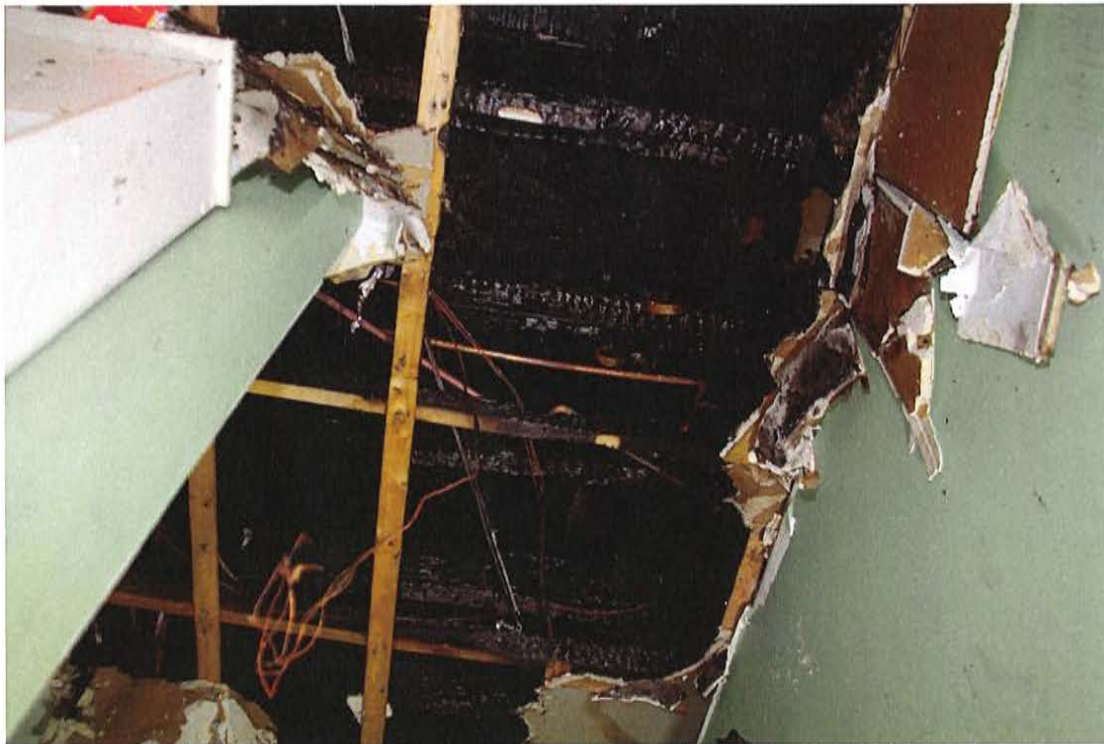
Photo: 2) Second floor bathroom area of fan and hole through to third floor

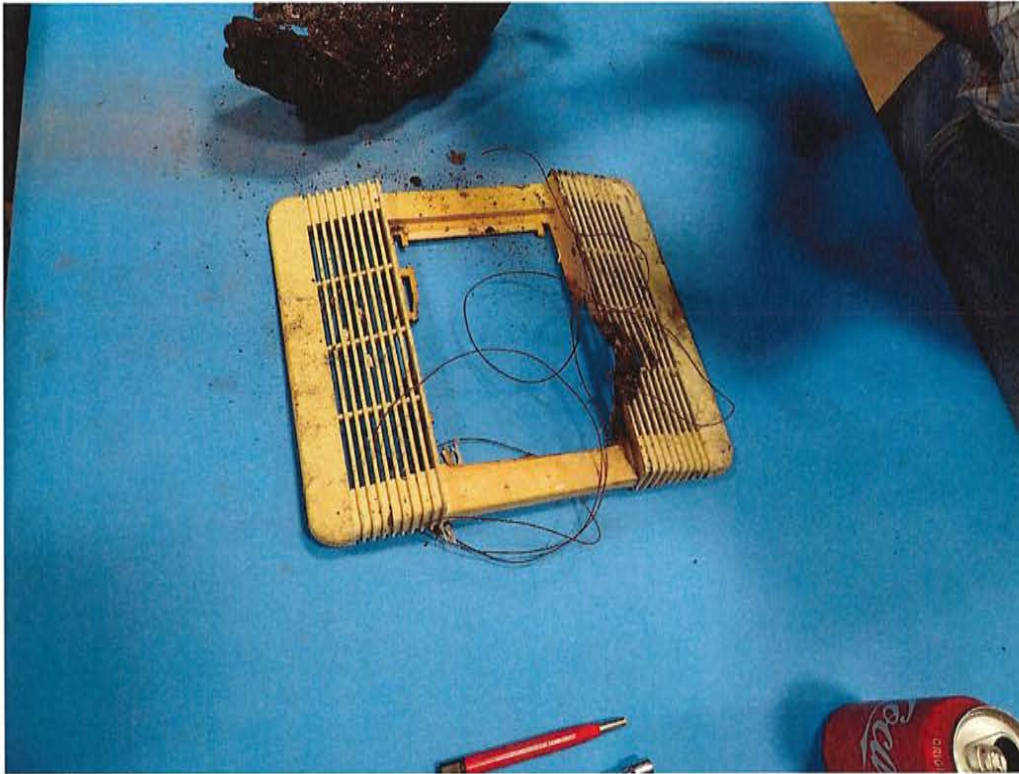
Photo: 4) Fan Components from Floor Debris

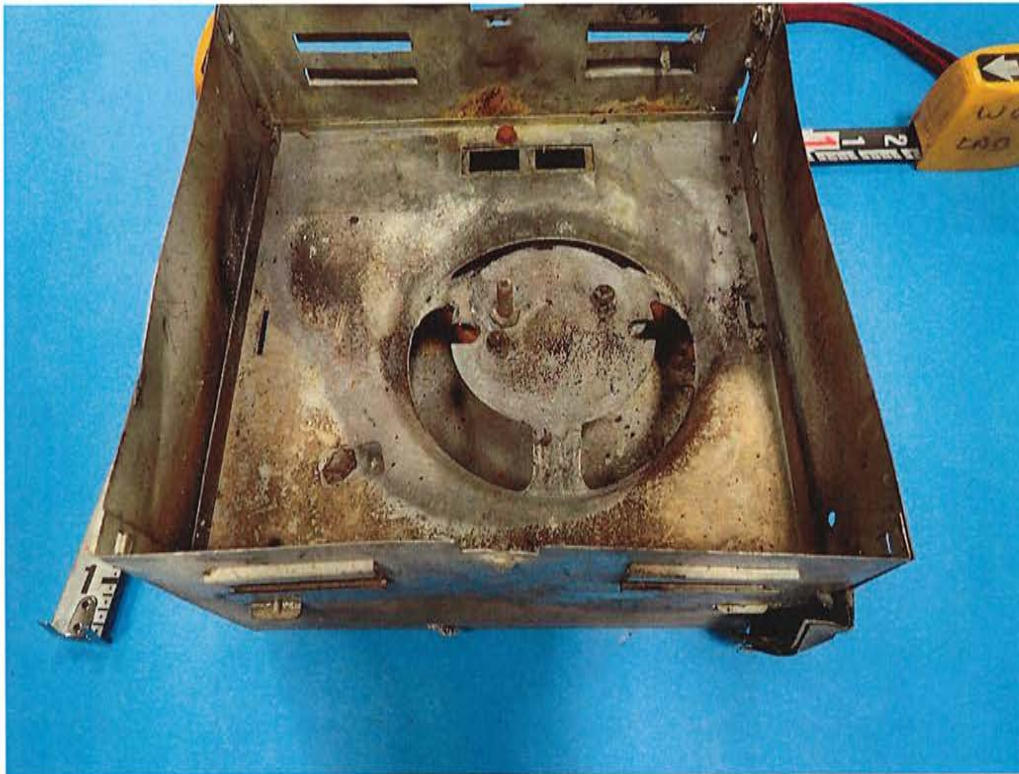
Photo: 5) NuTone Fan

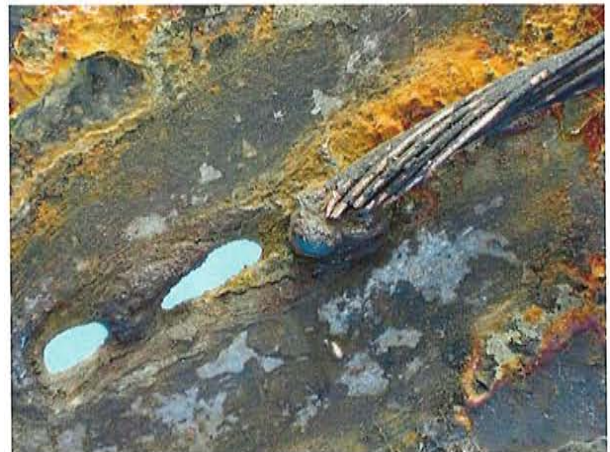
Photo: 7) Electrical activity internal to fan

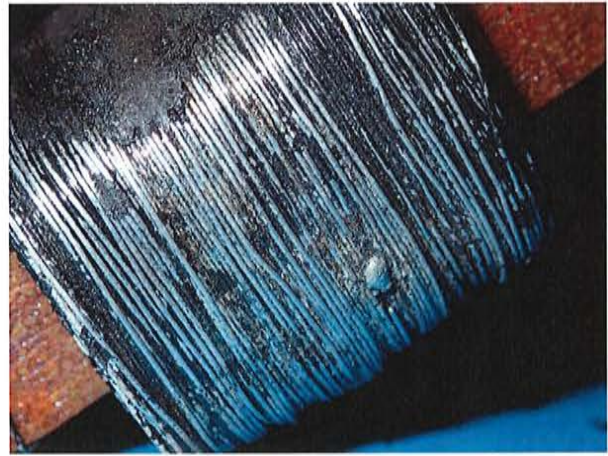
Photo: 9) Turn-to-turn damage on windings

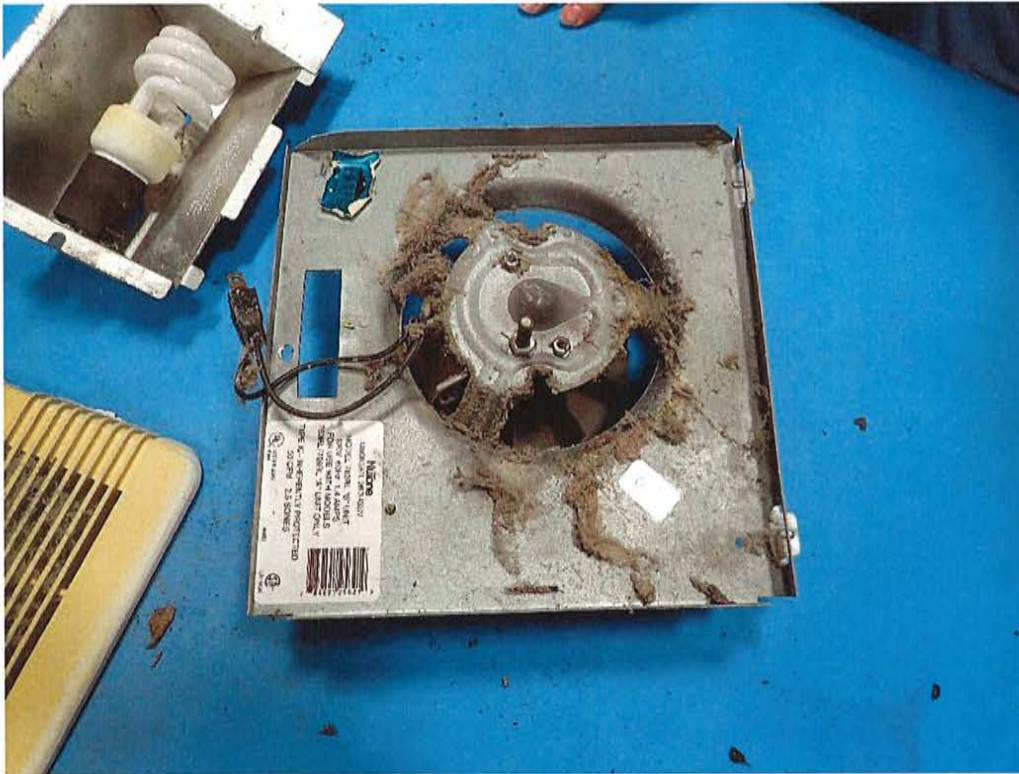
Photo: 10) Exemplar Fan from Second Floor Bathroom

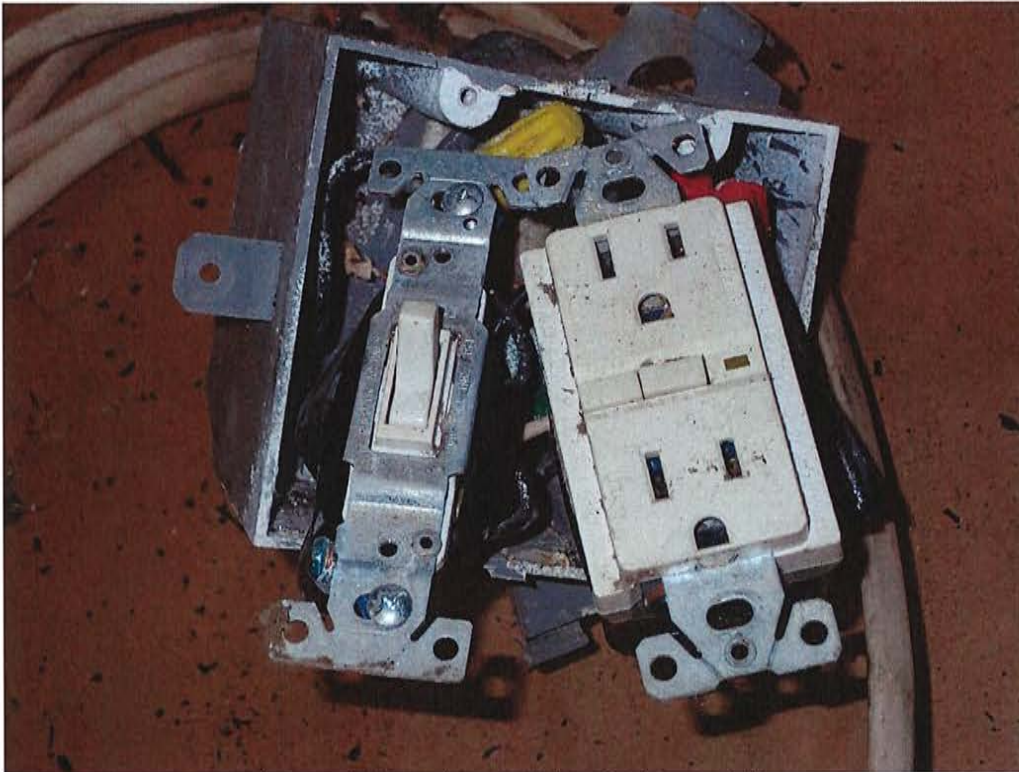
Photo: 11) Wiring from 2nd Floor Bathroom Ceiling

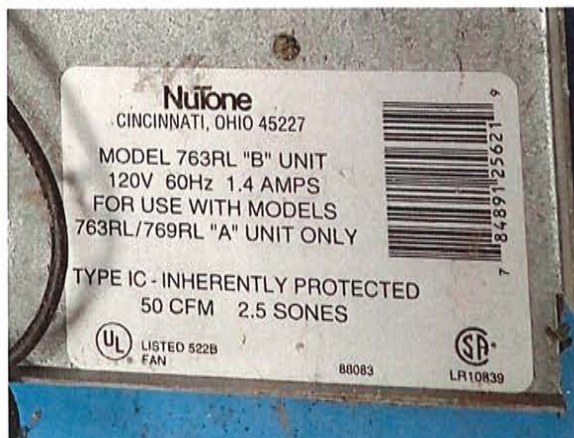
Figure 2) Exemplar name plate on fan
